Asbestos Survey Report

V.A. Medical Center - Building 8

February 28, 2005

ARM Project No. 09-102-04

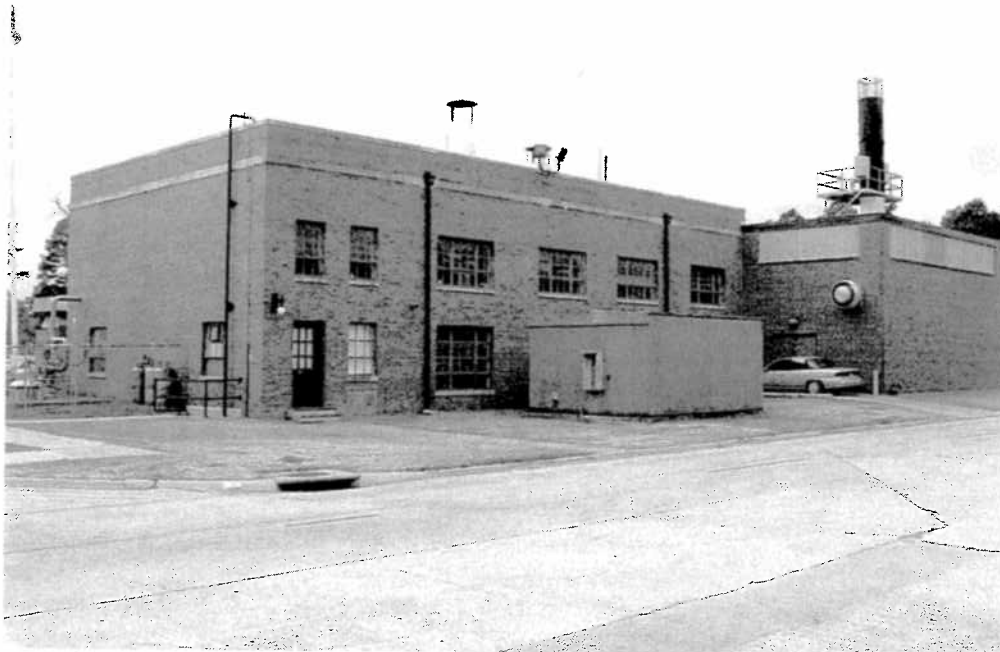
- 1) View of Building 8 looking west from Medical School Avenue. Building 8A is the gray metal building in front of Building 8.

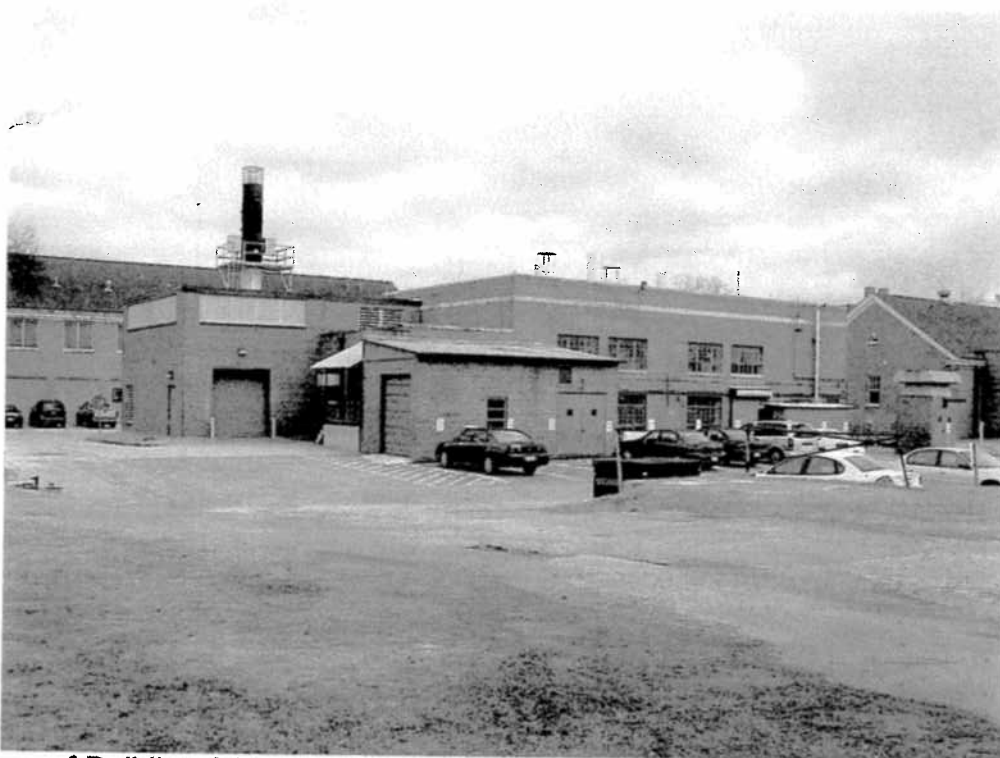
- 2) View of Building 8 looking east. The new incinerator room is the building to the left with a large smoke stack.
